INSPECTION REPORT

**Hitt Home
Inspection**

November 25, 2013

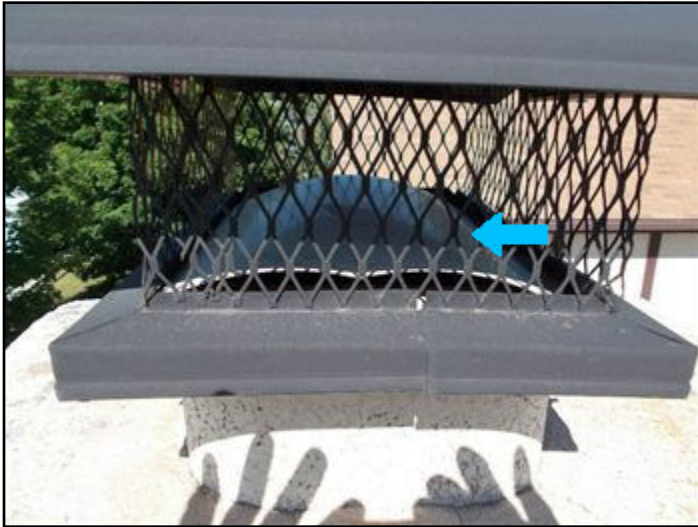
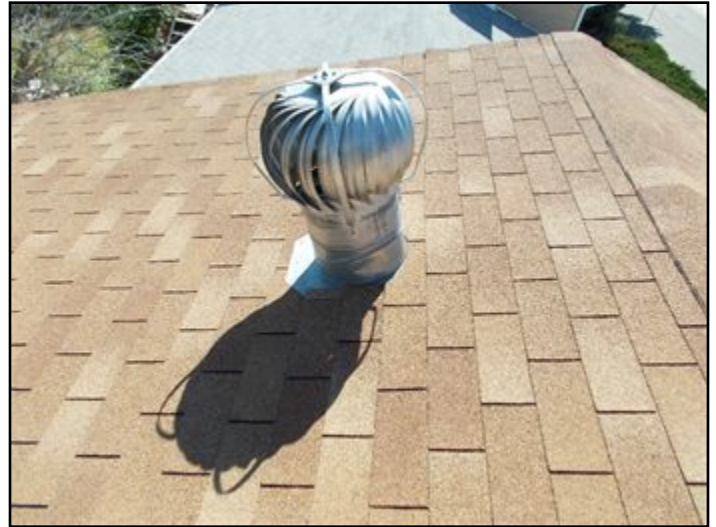
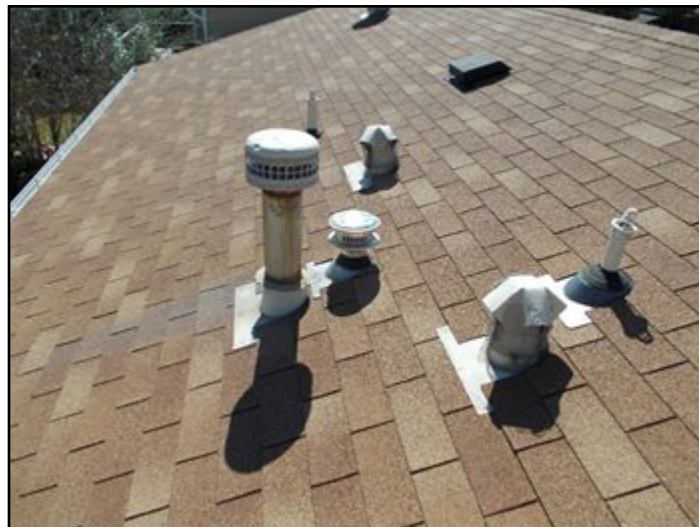
Roof looks newer in good condition, turban type roof vents

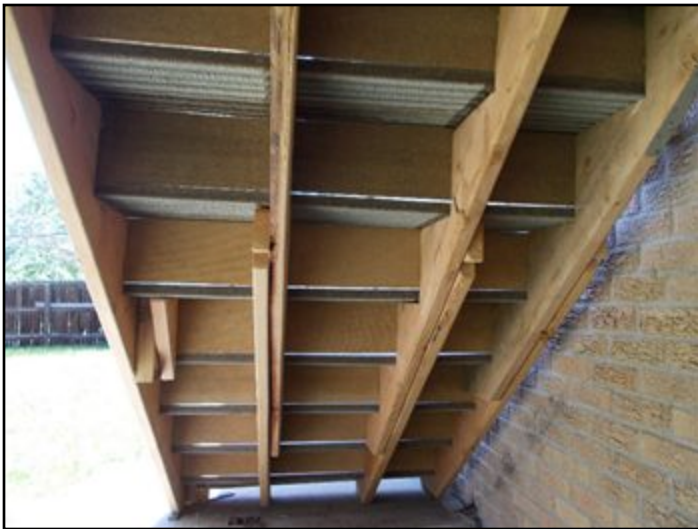
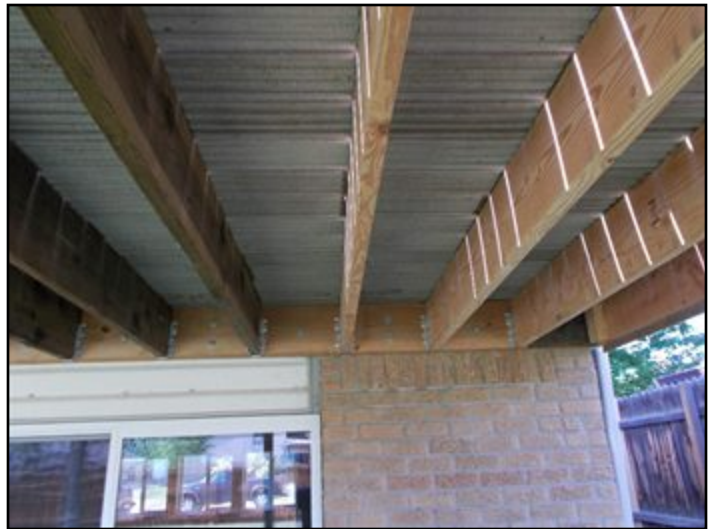
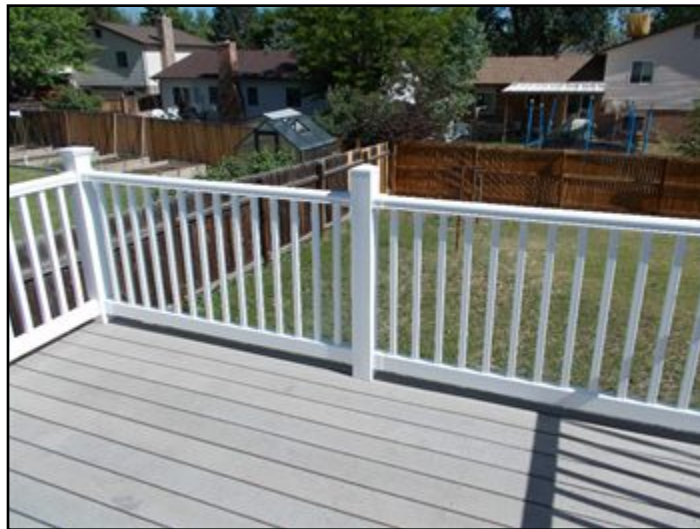
Deck has been rebuilt new framing underneath, Trex decking on top, new railing

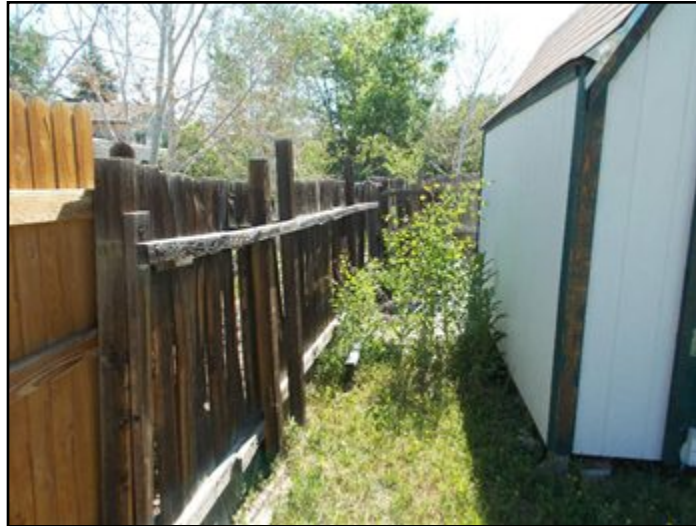
9. Wood

Fence behind shed has some rotten posts

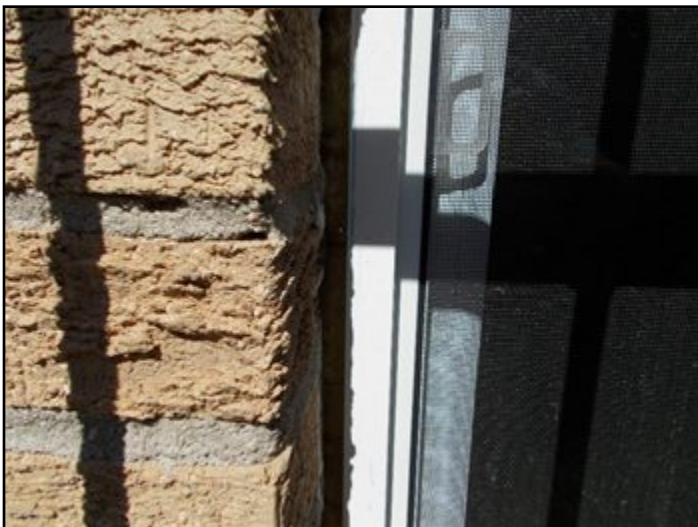
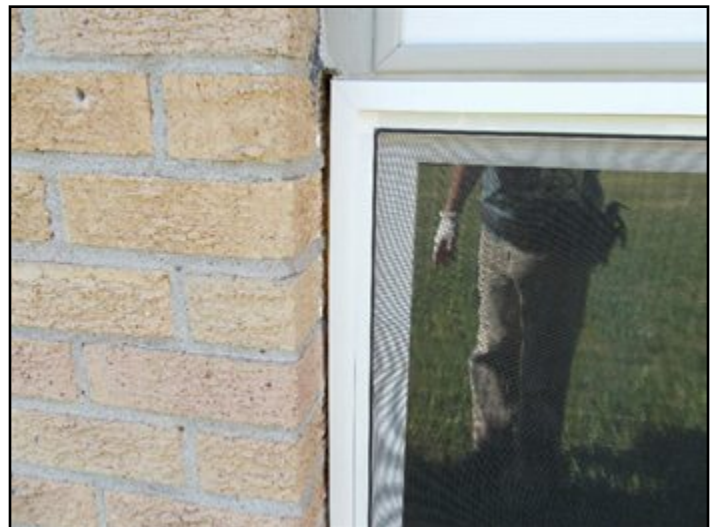
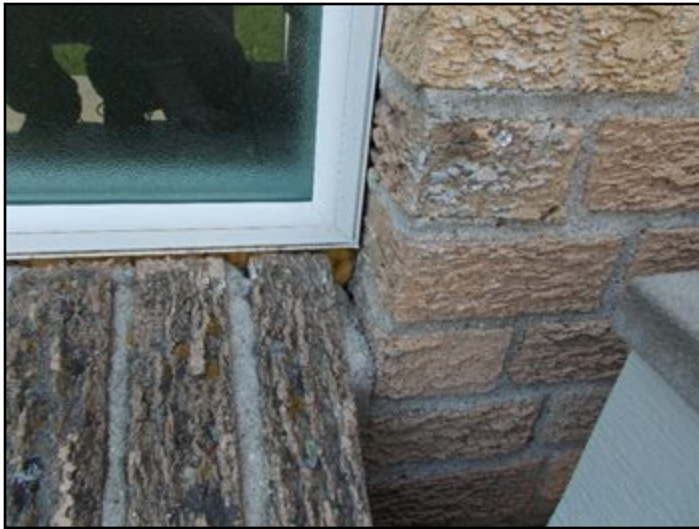
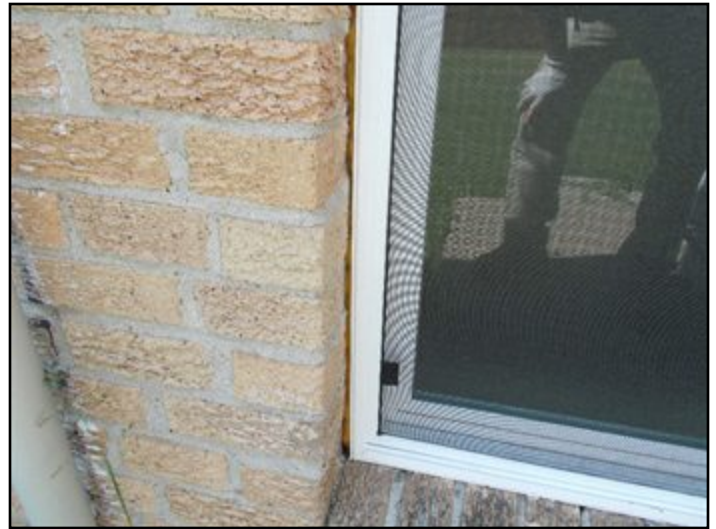
Condition: • Missing caulking on lower level windows, New windows need sealant at brick

1. **Condition:** • Missing caulking on lower level windows, New windows need sealant at brick

Task: Repair

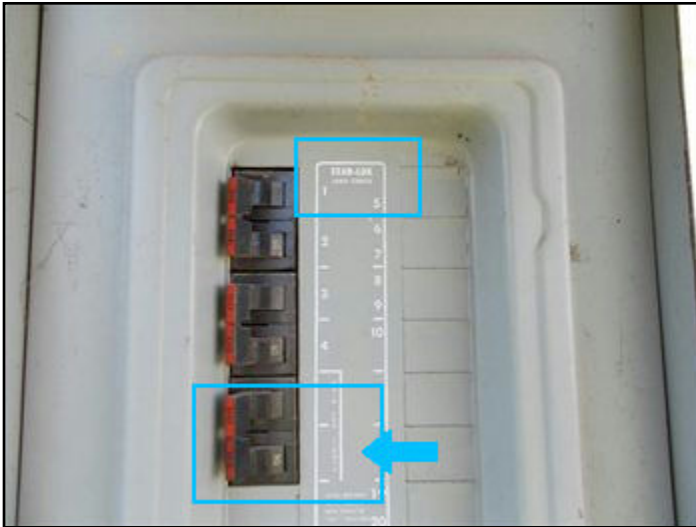
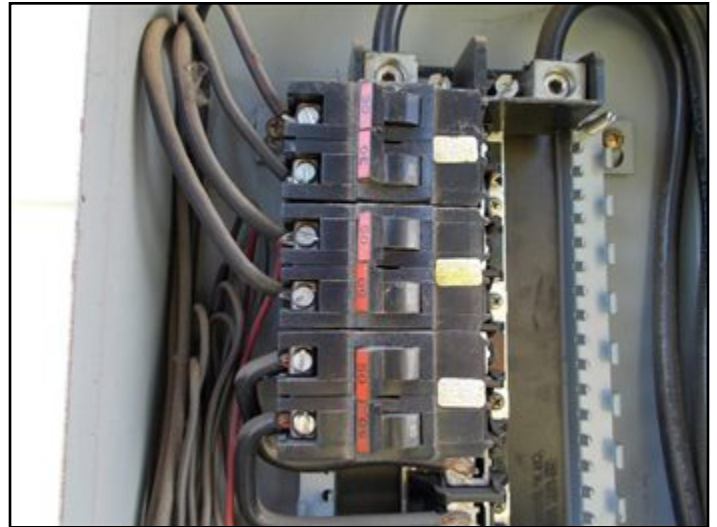
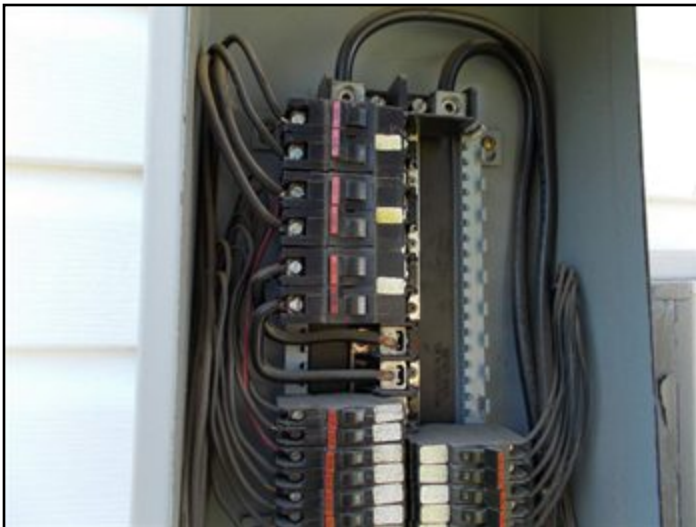
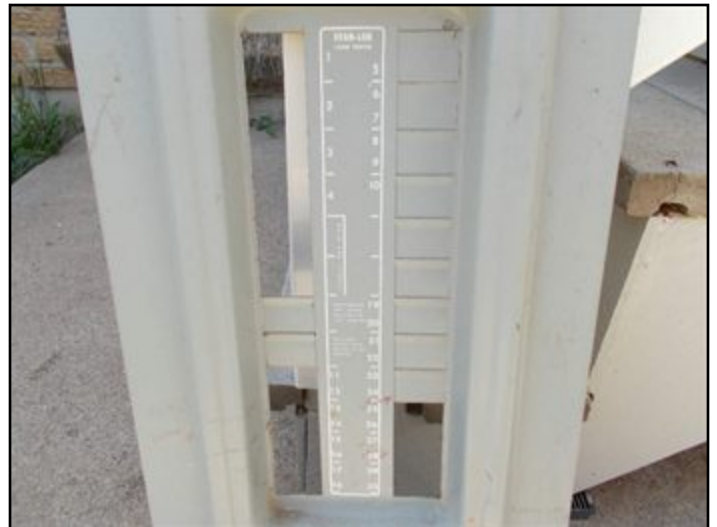
Federal Pacific Panel

19. Cover not well labeled

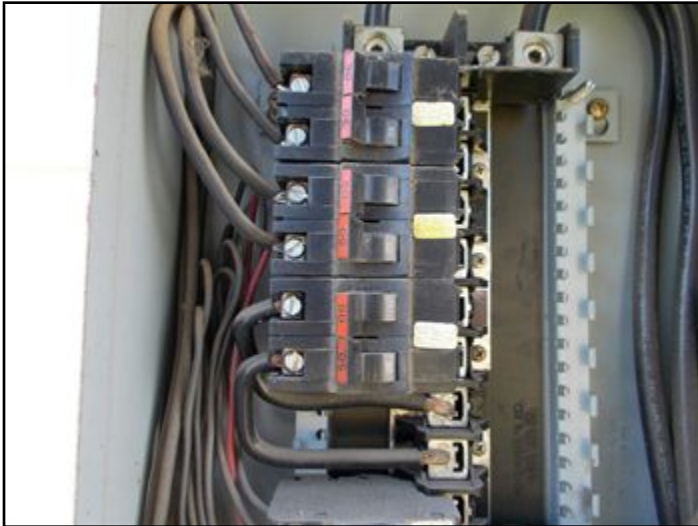
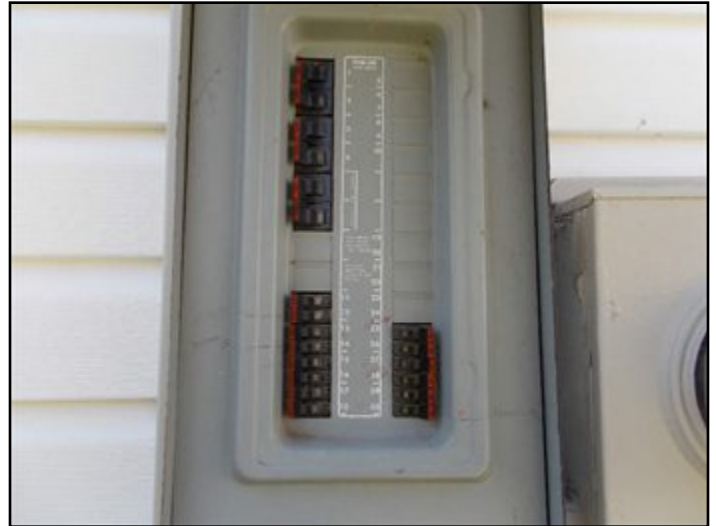
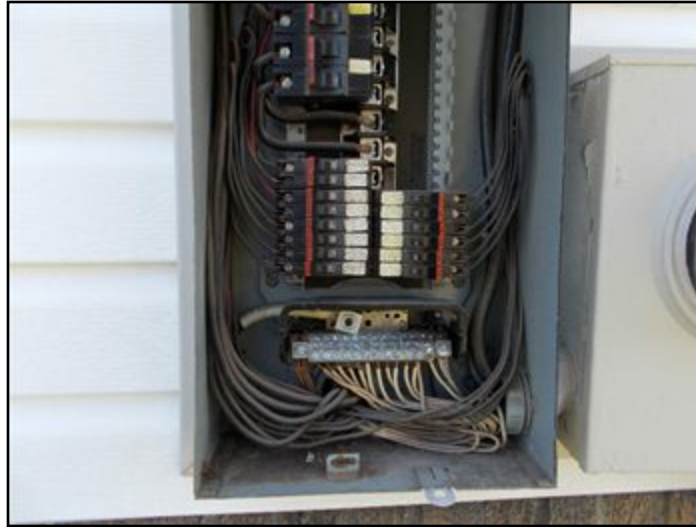
Condition: • [There are known problems with these panels, breakers have failed to trip causing possible overload, fire hazard](#)

2. Condition: • [There are known problems with these panels, breakers have failed to trip causing possible overload, fire hazard](#)

Task: Correct

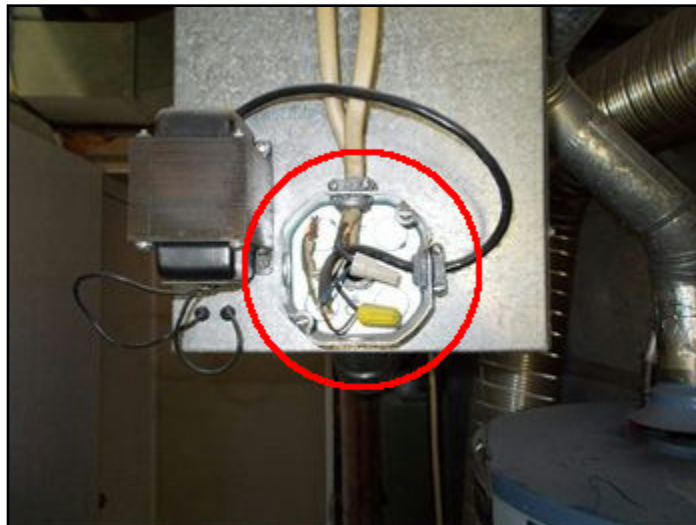
23.

3. Condition: • Loose connections and no cover

Location: Basement Utility Room

Task: Repair

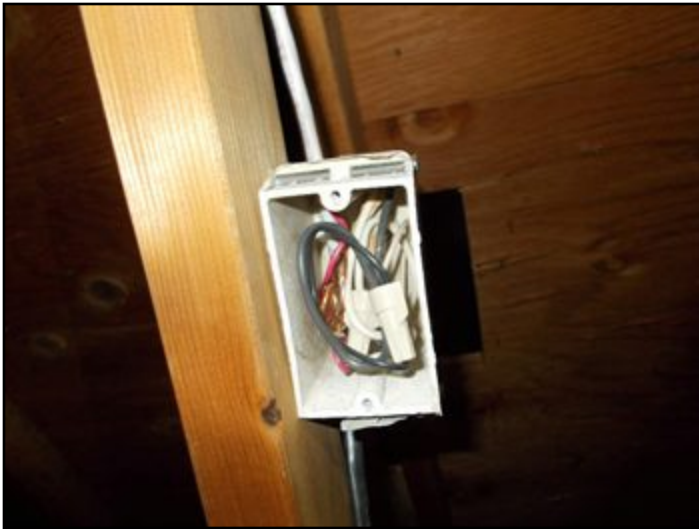
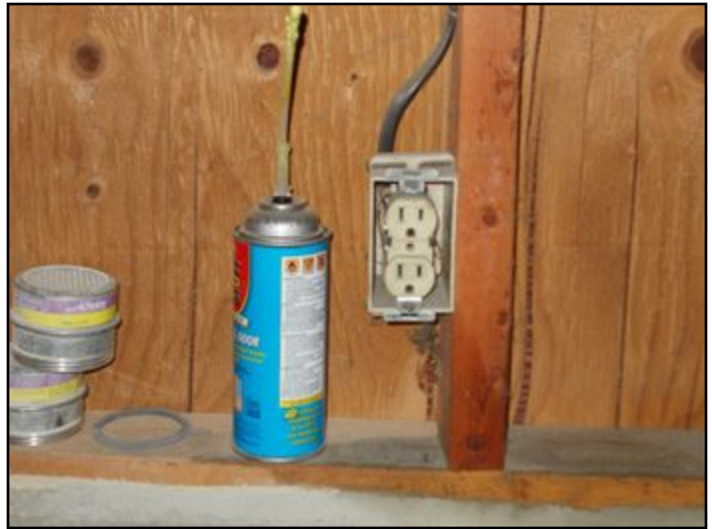
Junction box in attic needs a cover, receptacle in garage

4. Condition: • [Cover loose or missing](#)

Implication(s): Electric shock | Fire hazard

24. Cover loose or missing

Task: Repair

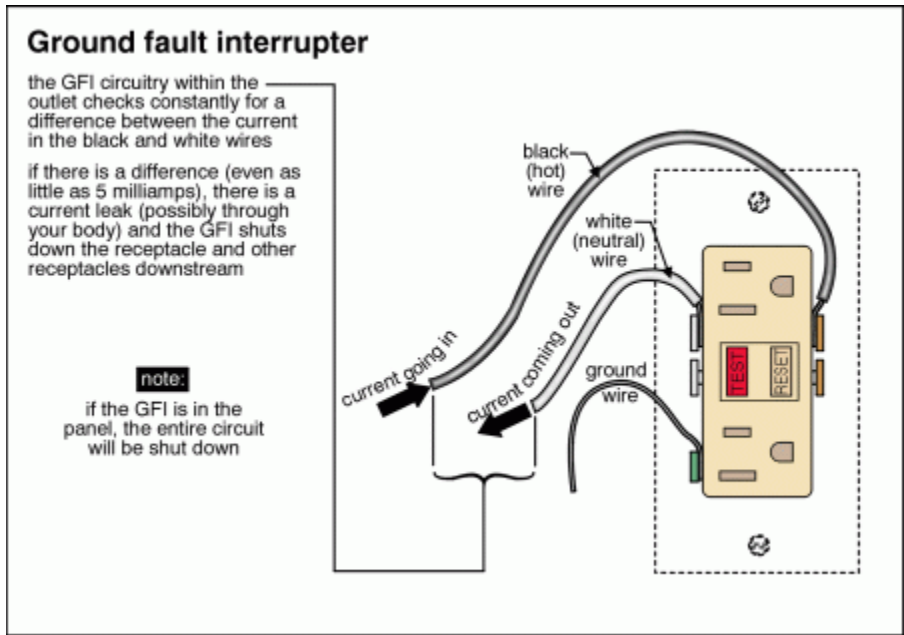
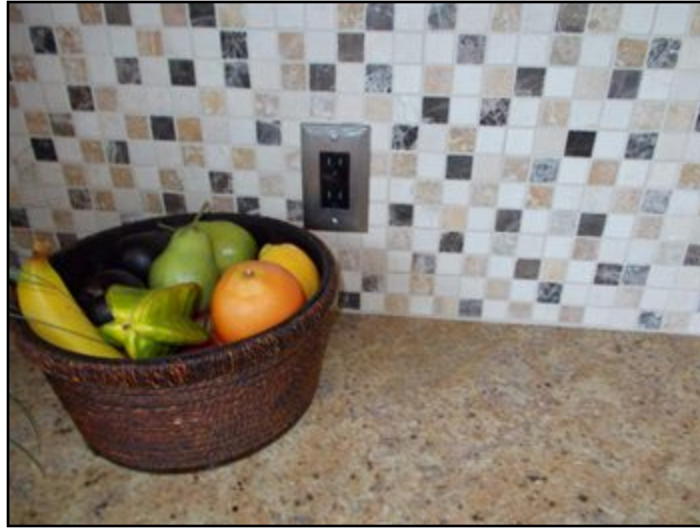
5. Condition: • [No GFI \(Ground Fault Interrupter\)](#)

left of stove this out let non GFCI

26. No GFCI (Ground Fault Interrupter)

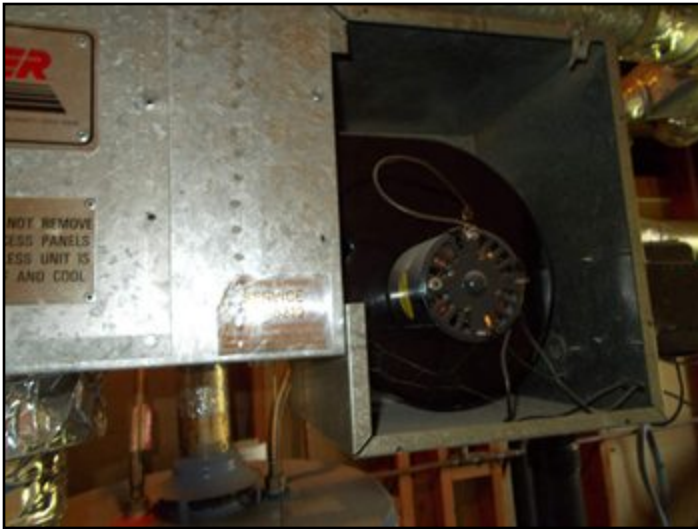
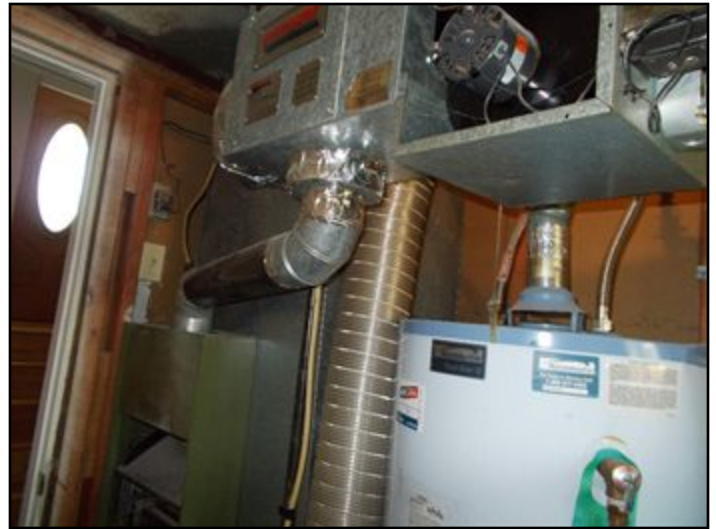
This heat reclaimer did not run during heating test

28. Energizer model AHH-6A heat reclaimer

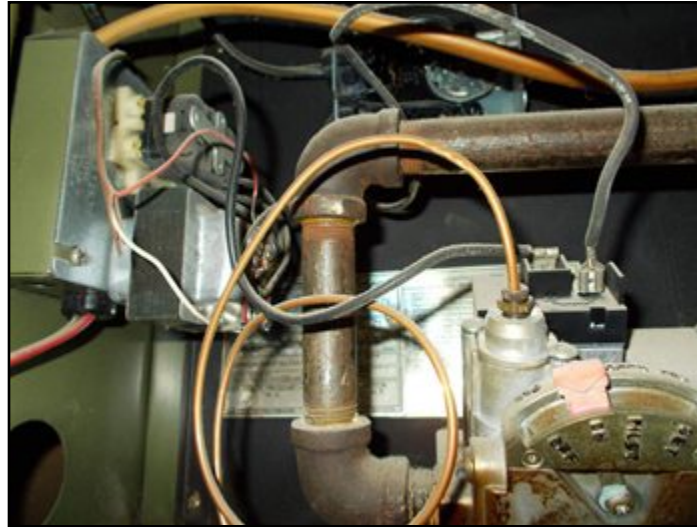
Approximate age: • [34 years](#)

Typical life expectancy: • Furnace (conventional or mid-efficiency) 18 to 25 years

6. Condition: • [Near end of life expectancy](#)

Implication(s): Equipment failure | No heat for house

31. Near end of life expectancy

Recommend clean and certify by Licensed HVAC contractor

Task: Further evaluation

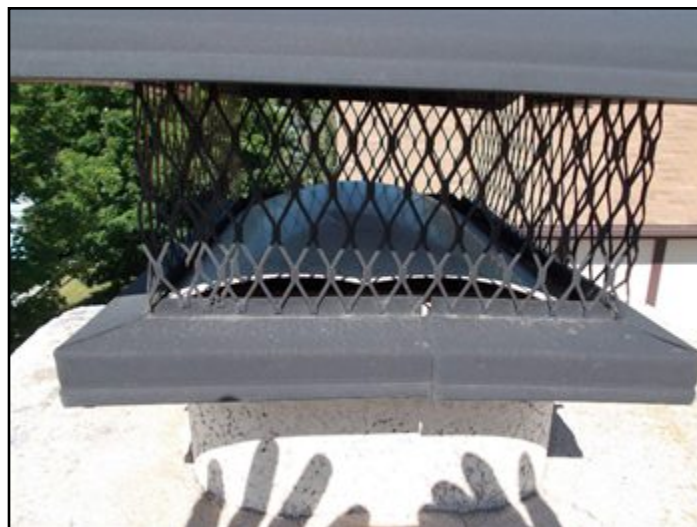
7. Condition: • looks like old floor tile used to cover top and reduce draft

Task: Repair

32. remove obstruction at chimney top
